National Transportation Safety Board

Marine Accident Brief

Accident No.: DCA-10-FM-003
Vessel No. 1: *Thriller 09*
Vessel No. 2: *CG 25689*
Accident Type: Collision
Location: Charleston Harbor, South Carolina
Date: December 5, 2009
Time: 2028 eastern standard time¹
Owner/Operator: *Thriller 09:* Foxrose, LLC
CG 25689: U.S. Coast Guard
Property Damage: *Thriller 09:* \$94,300
CG 25689: \$1,380
Injuries: *Thriller 09:* 6
CG 25689: 0
Complement: *Thriller 09:* 2 crew and 22 passengers
CG 25689: 3 crew

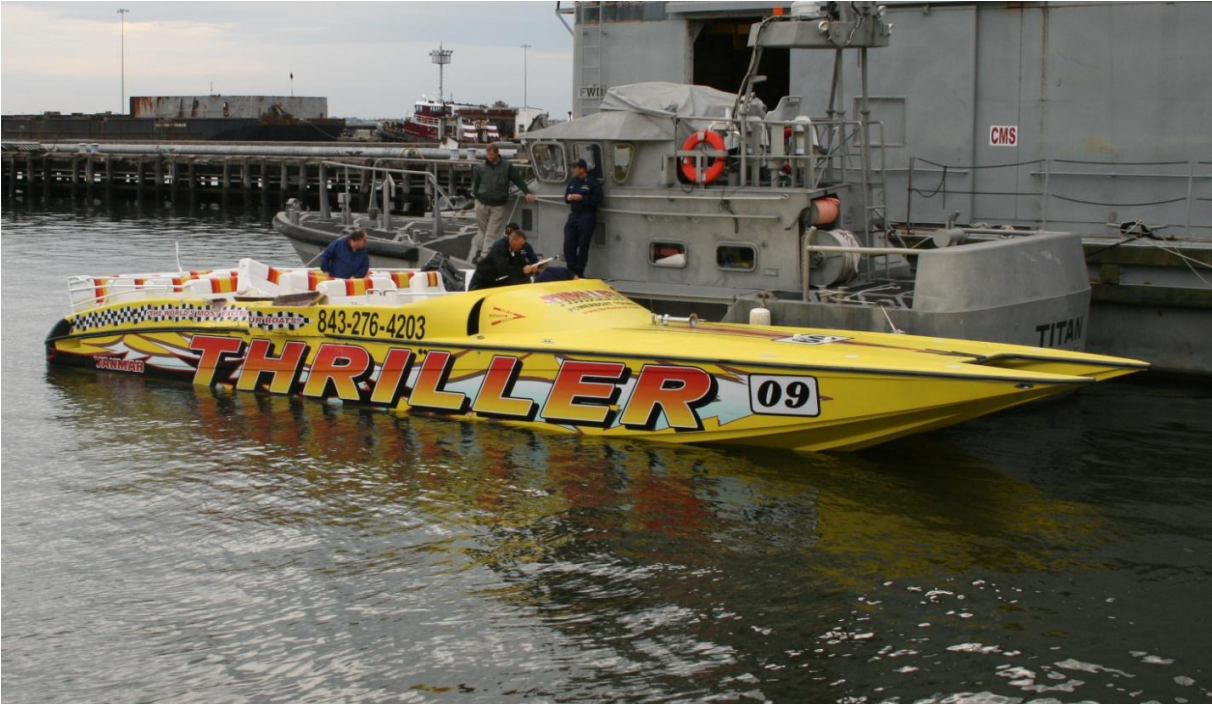
Figure 2. Profile view of *Thriller 09* postaccident.

their injuries, the master quickly determined that the *Thriller 09* was not taking on water. However, he found that a section of metal hand railing had broken off the starboard gunwale and that the vessel's hull was damaged above the waterline. In addition, the third bench seat on the starboard side had broken loose from the deck mounting near the outboard side where the impact had occurred, and the outboard portion of the seat had been displaced upward, about 1 foot in height.

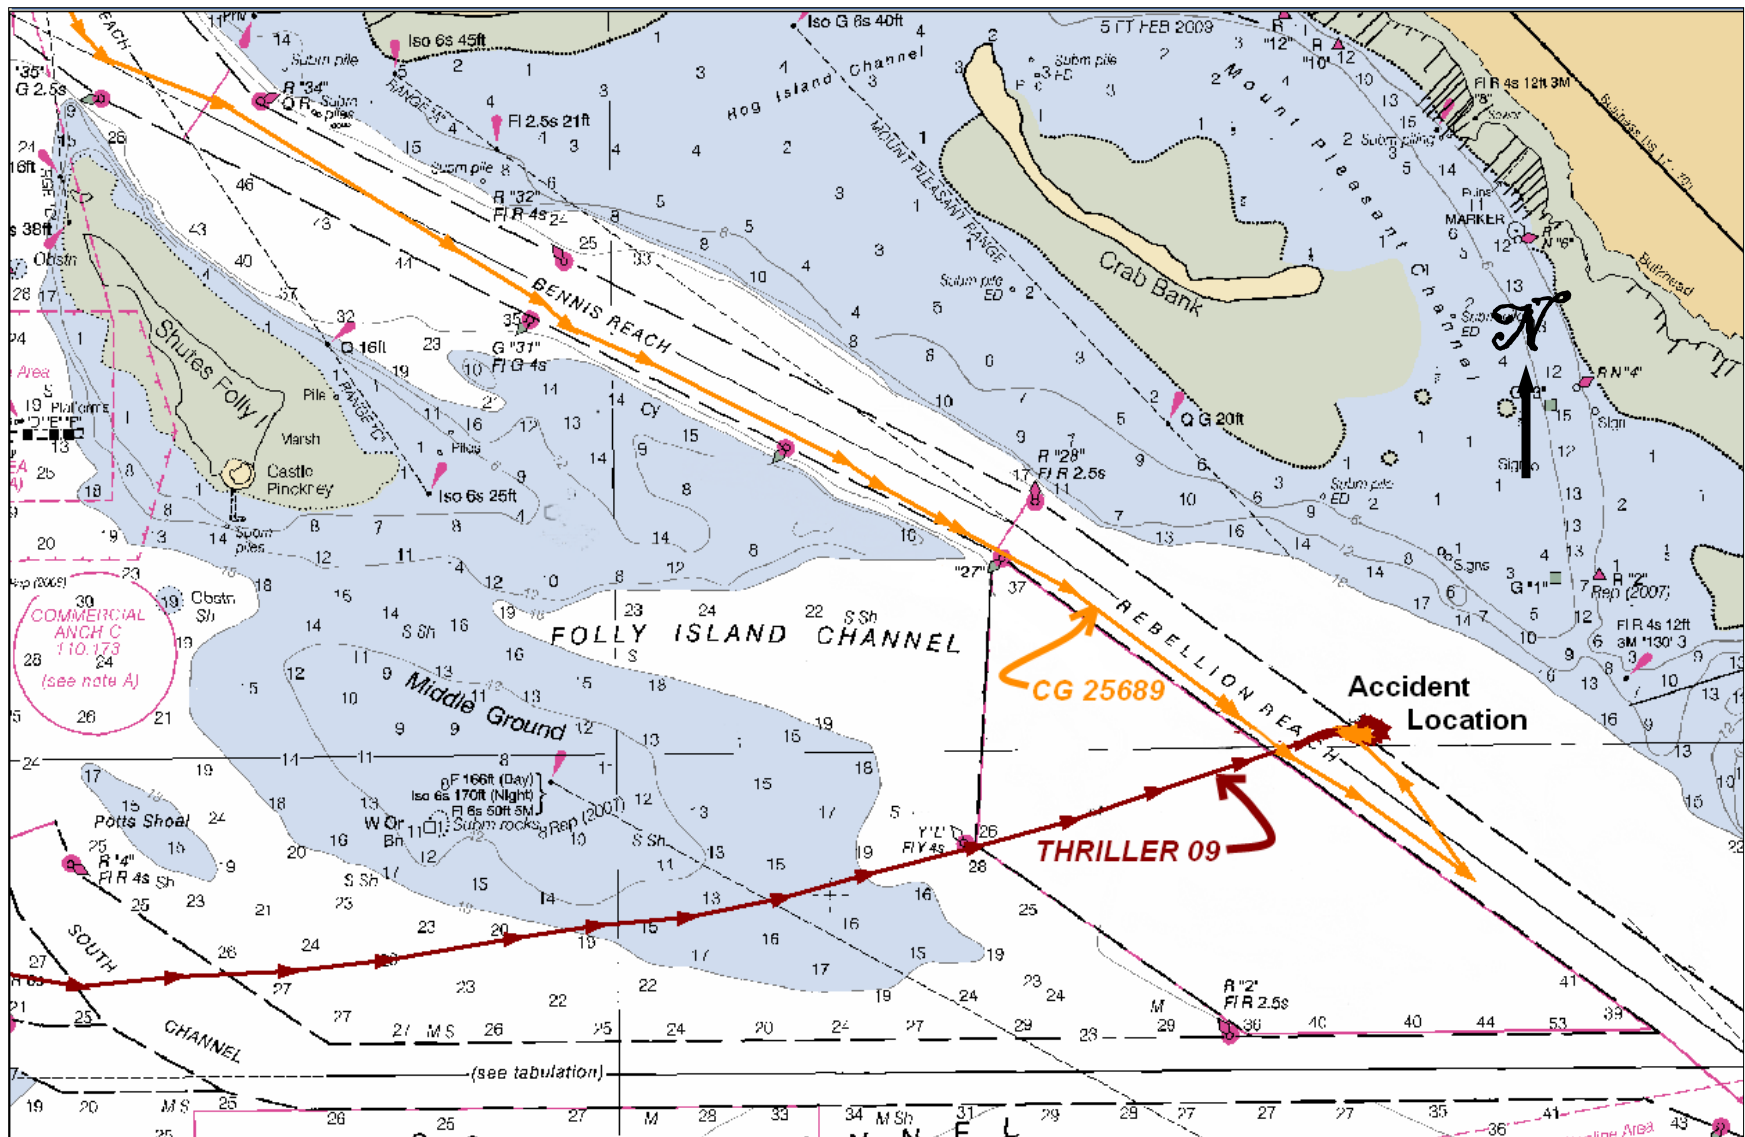
The track of the *CG 25689* was captured by the vessel's automatic identification system (AIS).⁸ The trackline appears in figures 3 and 4, as does the trackline of the *Thriller 09* as captured by its global positioning system (GPS). Evidence indicates that in the minutes before the accident, the *Thriller 09* and the *CG 25689* were approaching each other at an approximately constant bearing rate, as shown by the nearly parallel bearing lines in figure 4.

Figure 3. Tracklines of the CG 25689 (orange) and the Thriller 09 (red).

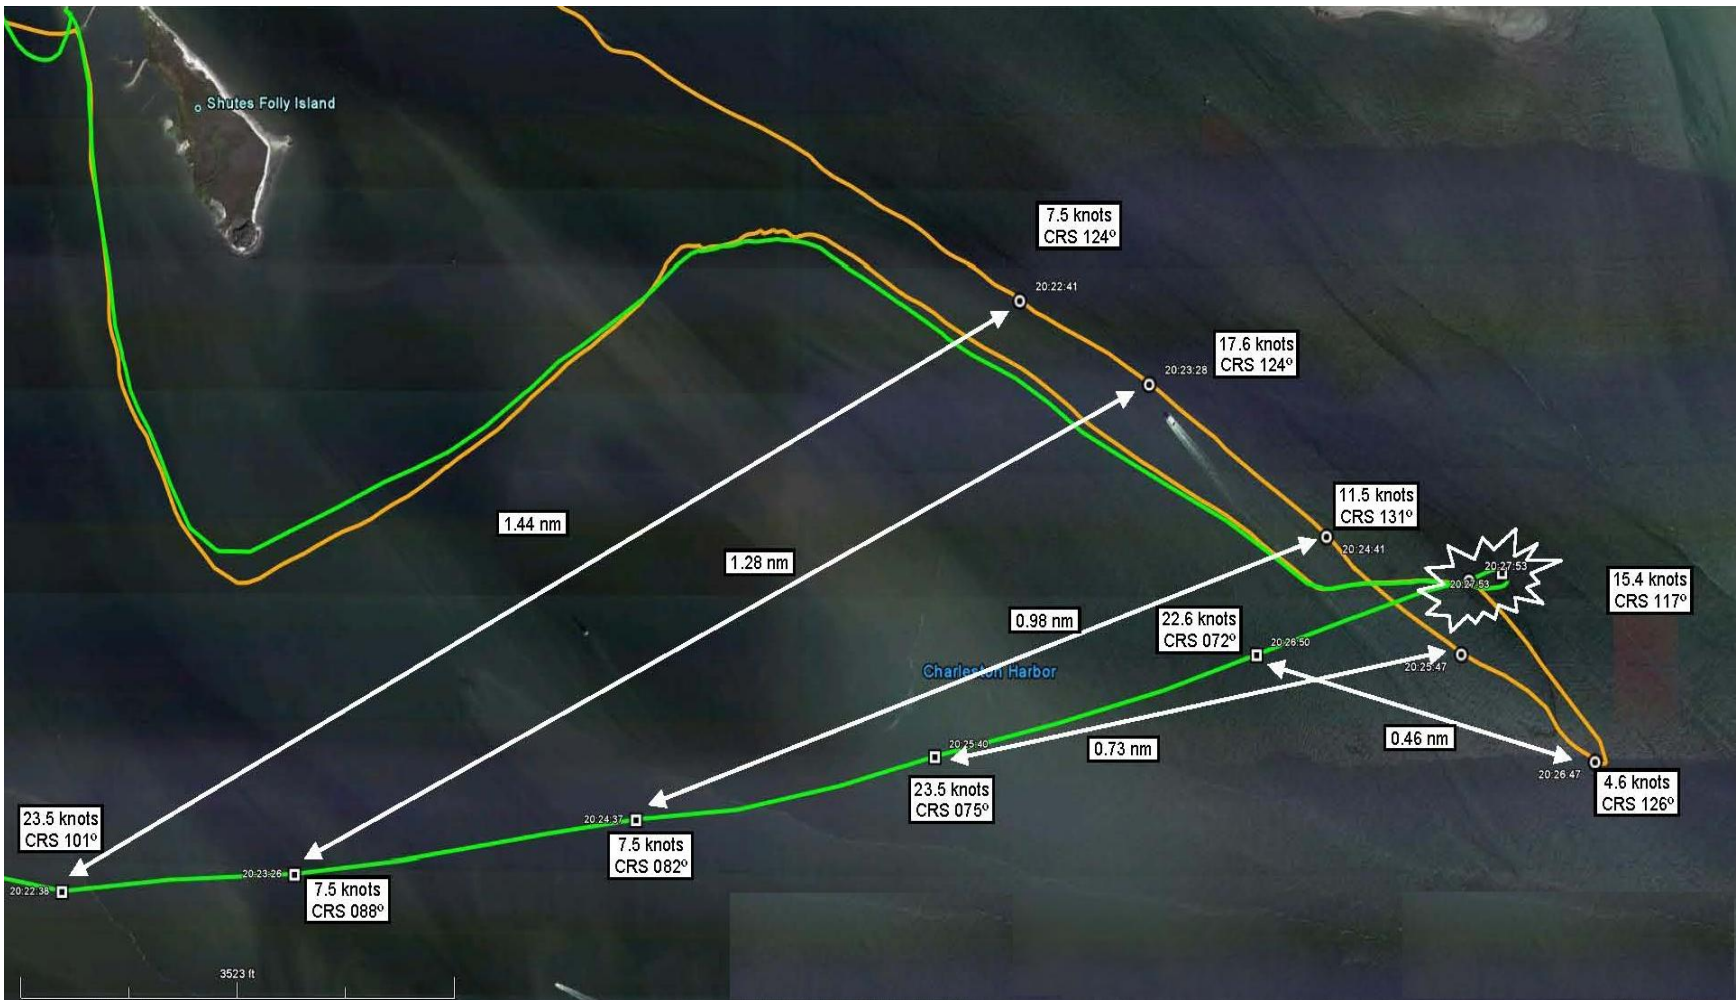
Figure 4. Graphic shows the tracklines of the CG 25689 (orange) and the *Thriller 09* (green). The white lines indicate the relative bearings between the vessels at various times. The star shape outlined in white indicates the approximate location of the collision. Background by Google Earth.

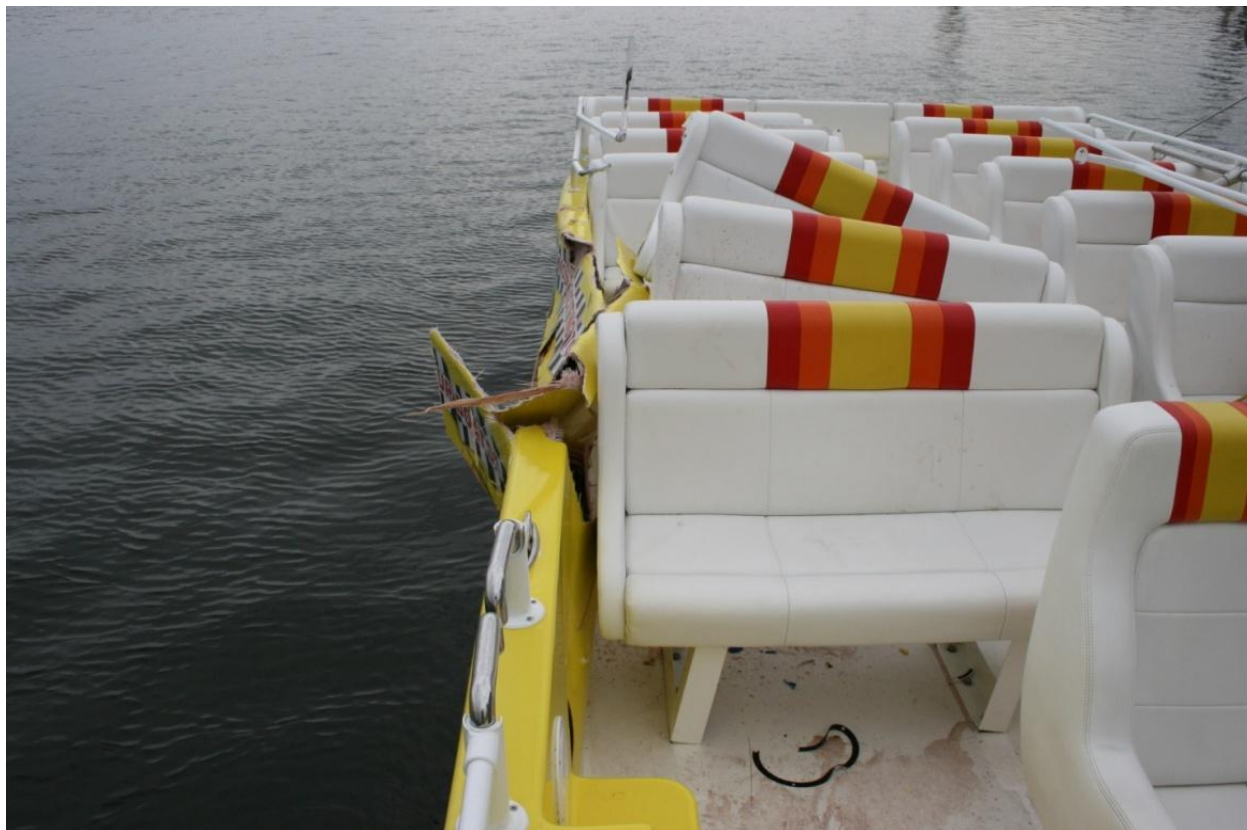
Damage. The *Thriller 09* sustained damage primarily to the starboard-side hull, above the waterline (figure 5). The damage in the impact area consisted of scratched, cracked, broken, and detached portions of the fiberglass hull shell, as well as fracturing of the interior hull framing and deck in this area. As a result of the collision, the starboard passenger bench seats at rows 2 and 3 were lifted and partially detached from the deck. The damage began 29 feet 7 inches from the bow and extended aft 12 feet 9 inches. According to the attorney for the boat owner/operator, the damage repair cost totaled \$94,300, excluding transportation and storage costs associated with shipping the boat to a Florida repair facility.

Figure 5. Damage to *Thriller 09* starboard side, looking aft from the bridge.

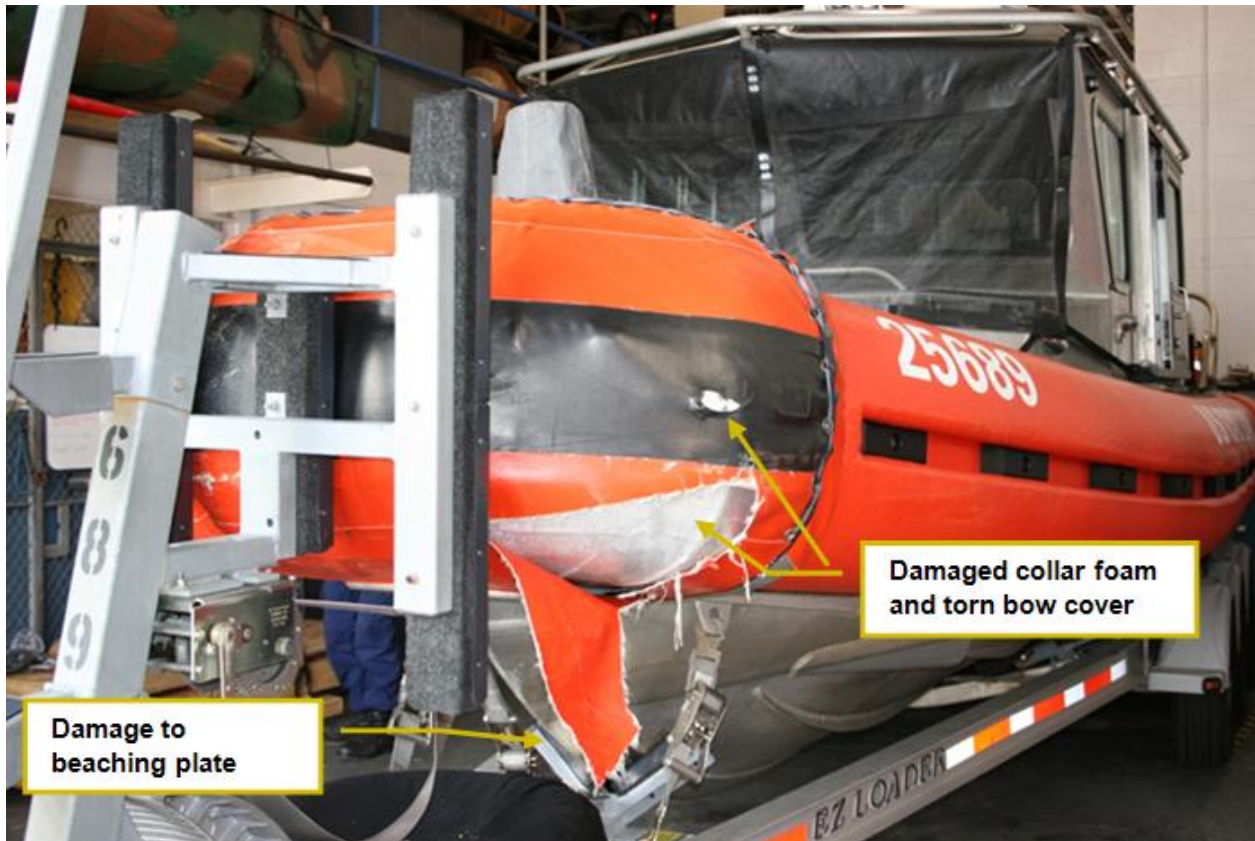
Damage. Damage to the *CG 25689* was limited to the bow area and consisted of one large (19- by 16- by 20-inch) tear in the bow fabric cover and several small tears, scuffs, scrapes, and similar damage to the cover (figure 6). In addition, the beaching (doubler) plate on the bow stem showed scuffing and impact damage but no apparent indentation or fracturing of the hull. The Coast Guard estimated the damage cost to total \$1,380, including the bow cover replacement, materials, and some hull welding.

Figure 6. Damage to the CG 25689's bow collar foam, bow cover, and beaching plate.

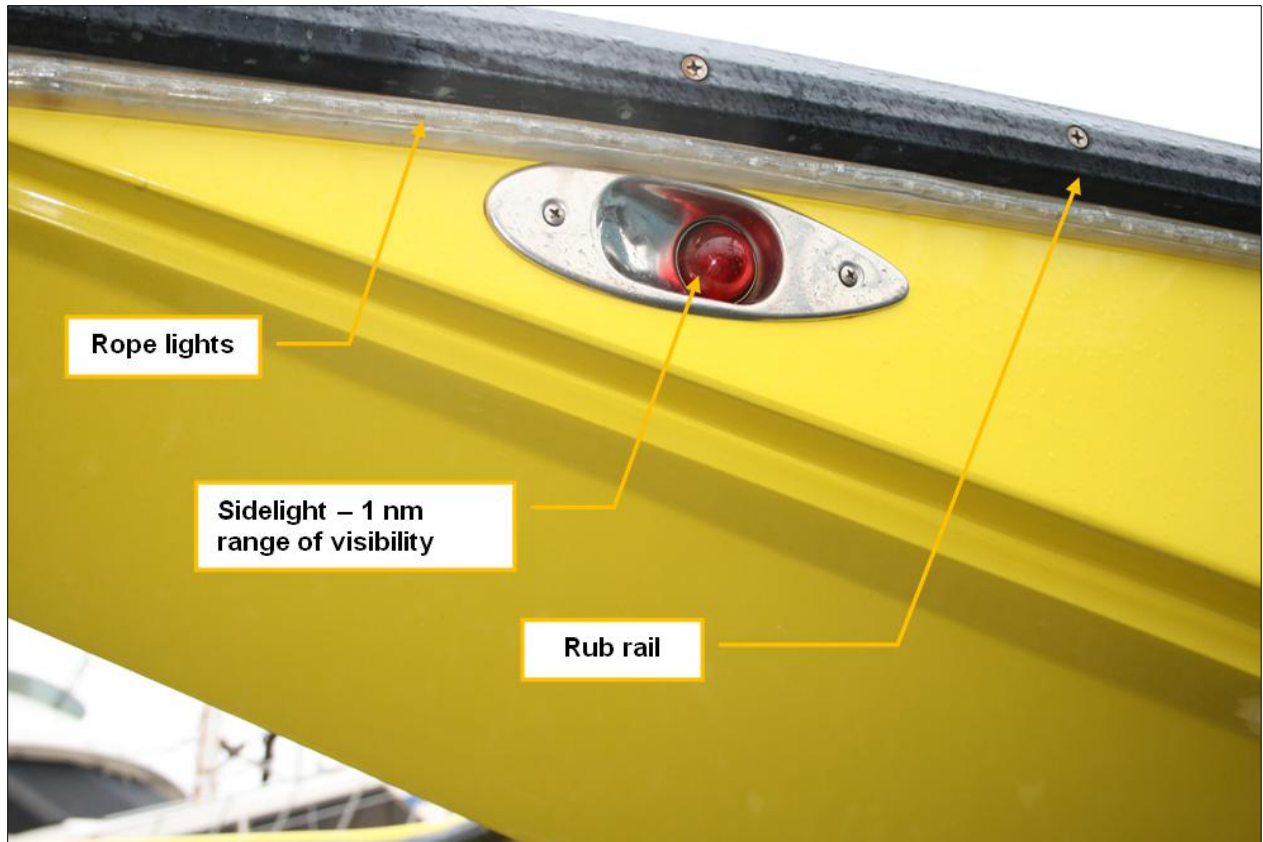
Both vessels were fitted with the required navigation lights for use during restricted visibility and nighttime operations. Crewmembers of both vessels and passengers of the *Thriller 09* reported that both vessels' lights were illuminated at the time of the accident. Investigators later verified that all required lights were operational. However, investigators identified two anomalies with the navigation lighting system of the *Thriller 09*. First, its port and starboard navigation sidelights, fitted at the outboard sides of each of the catamaran's bows, had range of visibility ratings of 1 nm rather than 2 nm as required by the navigation rules. In addition, the boat had decorative rope lights installed around the perimeters of its hulls, just below the rub rail (figure 7). According to the rope light manufacturer's specifications, the LEDs in the rope lights had a luminous intensity rating that exceeded the rating of the navigation sidelights.¹⁴

Figure 7. View of portside navigation sidelight and rope lights at the *Thriller 09*'s bow.

Thriller Boats. After the accident, the Coast Guard required the owner/operator of the *Thriller 09* to modify the navigation sidelight installation to meet the 2-nm range of visibility requirements of navigation rule 22, Visibility of Lights (within part C of the inland navigation rules, Lights and Shapes).¹⁵ The owner was permitted to keep the rope lights installed on the boat but was prohibited from illuminating them when the vessel was under way.
