Fire Aboard Construction Barge *Athena 106*  
West Cote Blanche Bay, Louisiana  
October 12, 2006

ACCIDENT REPORT

NTSB/MAR-07/01  
PB2007-916401

# Marine Accident Report

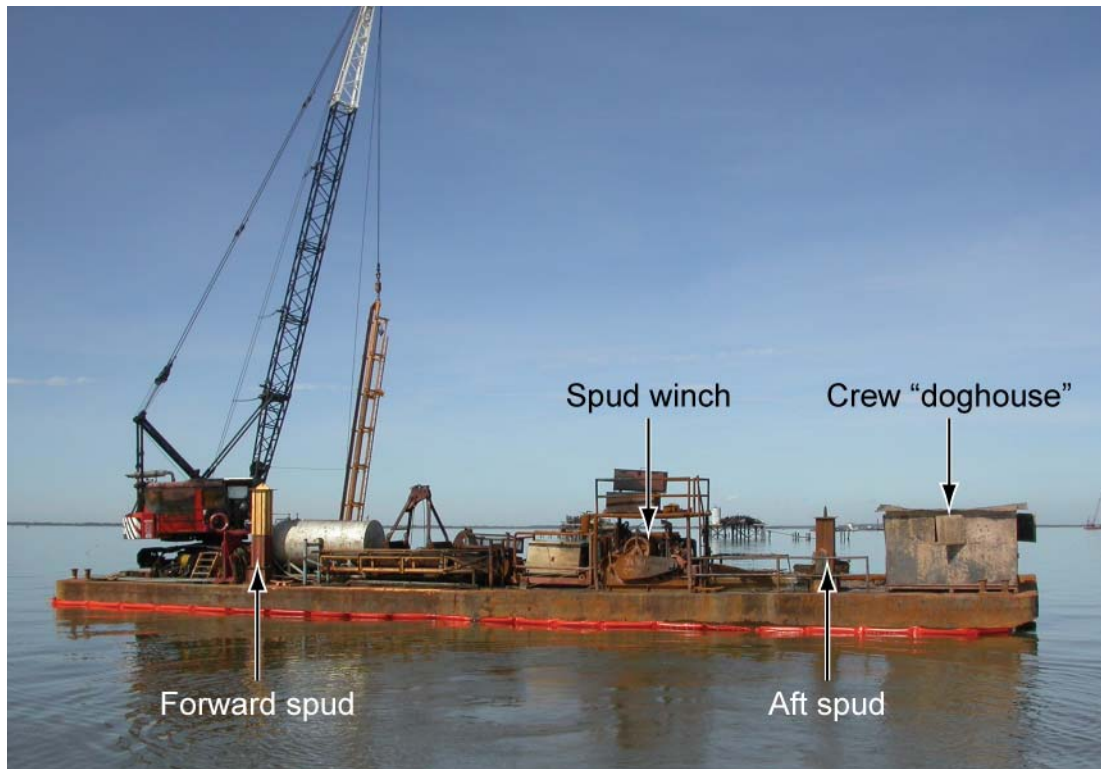
**Figure 2.** *Athena 106* after the fire. The construction barge was equipped with two mooring spuds (shown in the lowered position), both on the port side, one forward and one aft, controlled by a single winch. At the front of the barge was the crane used to hoist and position pilings for driving or to maneuver them to a barge alongside for storage.

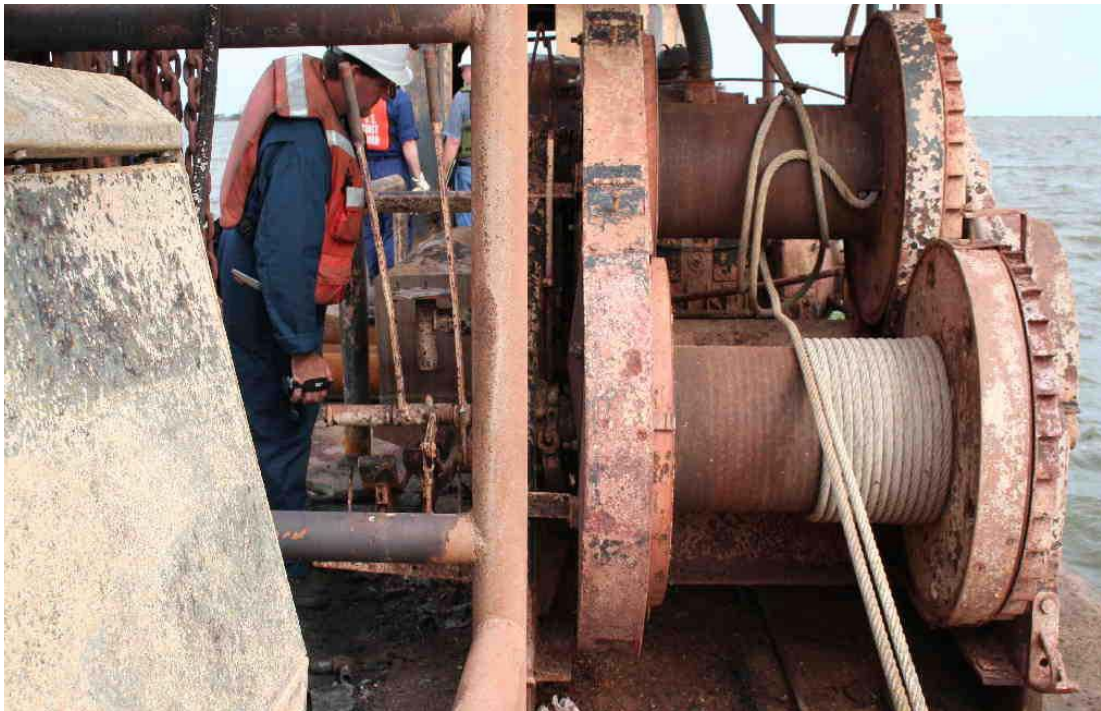
**Figure 6.** Photo showing cable “birdnested” on the winch drum (upper rear) that led to the *Athena 106*’s aft spud. The cable on the lower winch, which led to the forward spud, is properly wound.

**Athena 106.** Investigators found both the forward and aft spuds on the *Athena 106* in the lowered position (as noted below, they were informed by the recovery crew that the forward spud had been in the raised position until it fell during the recovery effort). The 7/8-inch steel cables connecting the spuds to the barge's winch were examined for signs of preexisting damage and found to be free of any fraying or other visible defects. The cable leading from the winch to the forward spud exhibited a light strain condition, with its remaining turns wrapped uniformly around the lower winch drum. The cable connecting the aft spud to the winch was found completely fouled on the upper winch drum, or "birdnested," with none of its remaining cable turns on the drum still wrapped on the inner drum surface (figure 6).

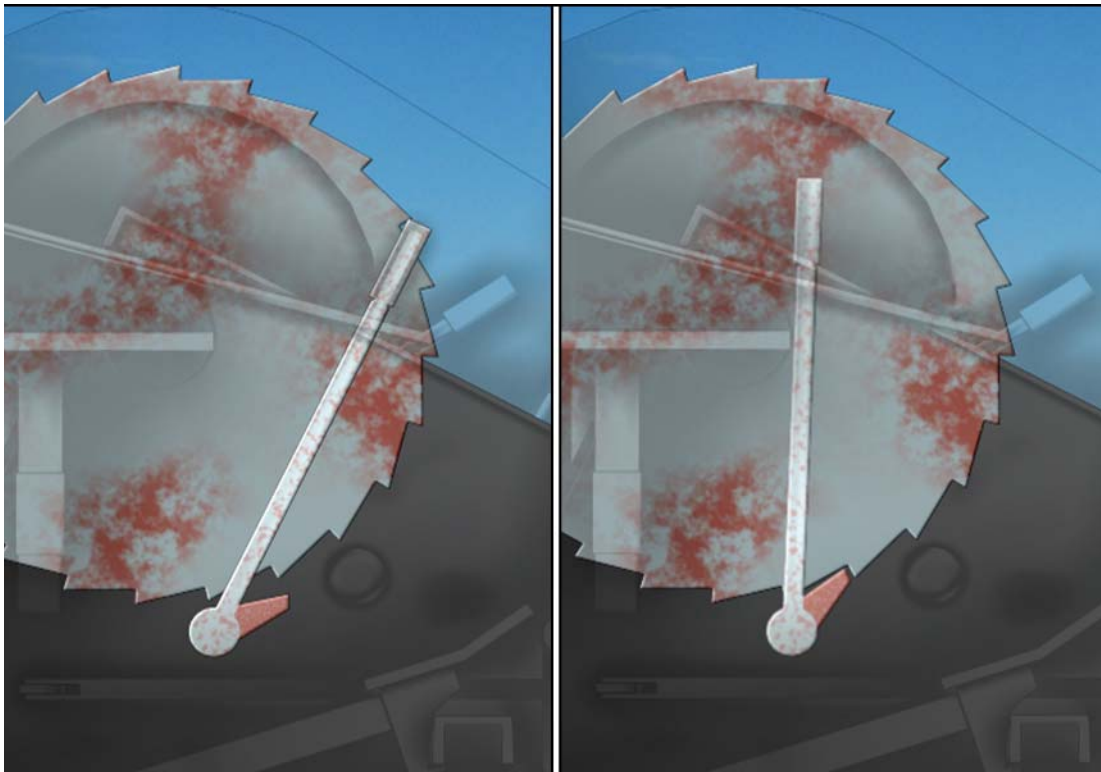
**Figure 10.** Operation of the winch pawl on the *Athena 106*. The operator engages or disengages the pawls using the lever, shown in white, that extends downward across the gear. The pawl is the tongue-shaped piece at the bottom of the lever. When disengaged (left illustration), the pawl is outside the gear teeth, allowing the gear to move freely in either direction. When engaged (right illustration), the pawl falls into the spaces between the notches so the gear can move in only one direction. (See figure 8 for location of pawl lever at operator's station.)

Both the upper and lower winch drum hand friction control levers were found disengaged. Both spud winch drum pawls were found in the disengaged position. The spud winch's fuel tank, integral with the winch frame, was split open and deformed by the fire's heat. The 36-inch-by-2-inch spud securing pins were found lying next to their respective spud bases, not inserted into the spuds.

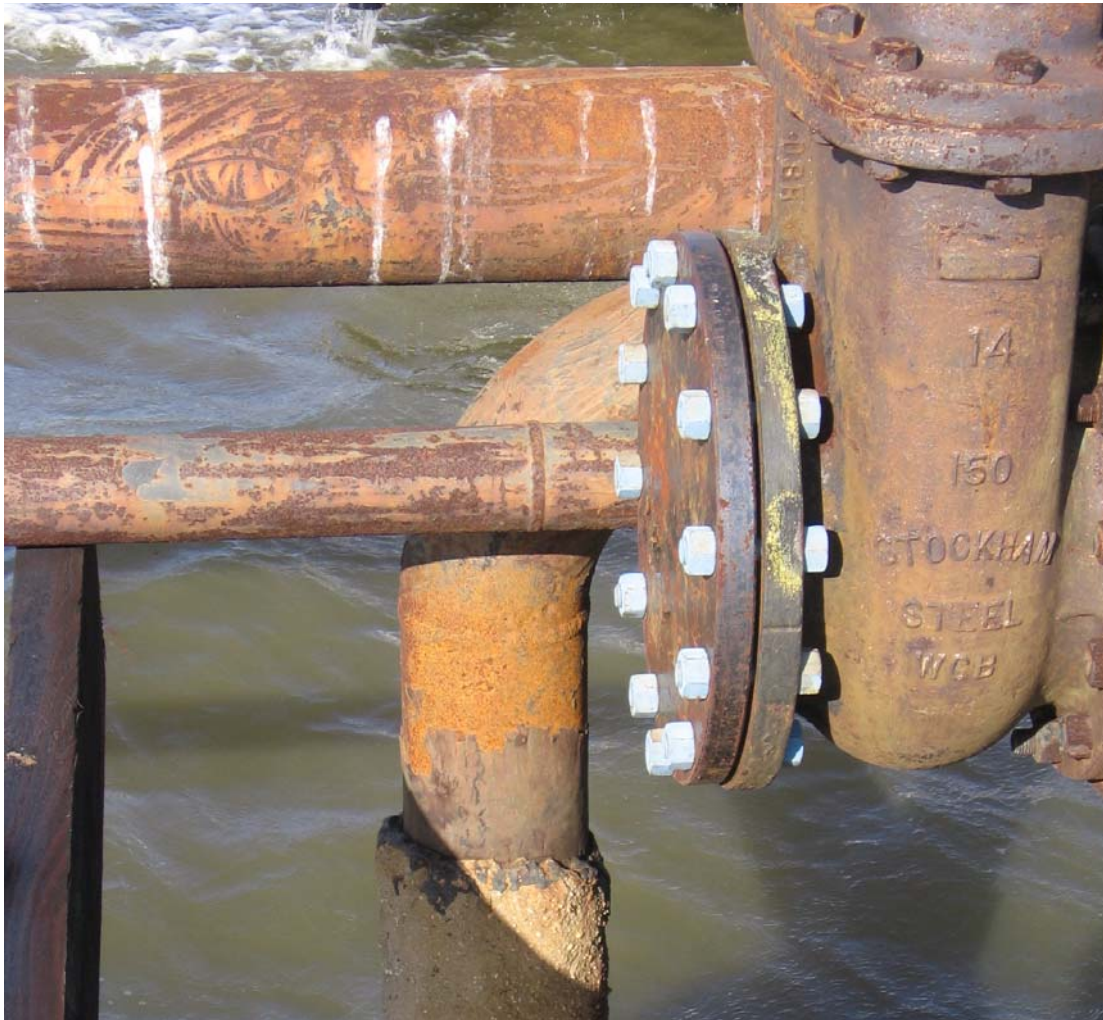
**Figure 14.** Beginning of the gas sales pipeline (vertical pipe entering water) at the Gulfport sales platform in the West Cote Blanche Bay oil field. The pipeline was ruptured by the *Athena 106*'s aft spud in an east-west section near the Gulfport platform. The pipe's concrete coating is visible above the waterline.
