**Allision of Staten Island Ferry *Andrew J. Barberi*
St. George, Staten Island, New York
October 15, 2003**

Marine Accident Report

NTSB/MAR-05/01

Abstract: This report discusses the allision of the passenger ferry *Andrew J. Barberi* with maintenance pier B-1 at the Staten Island ferry terminal on October 15, 2003. The ferry carried an estimated 1,500 passengers and 15 crewmembers. Ten passengers died in the accident and 70 were injured. An eleventh seriously injured passenger died 2 months later. Damages totaled more than \$8 million, with repair costs of \$6.9 million for the *Andrew J. Barberi* and \$1.4 million for the pier.

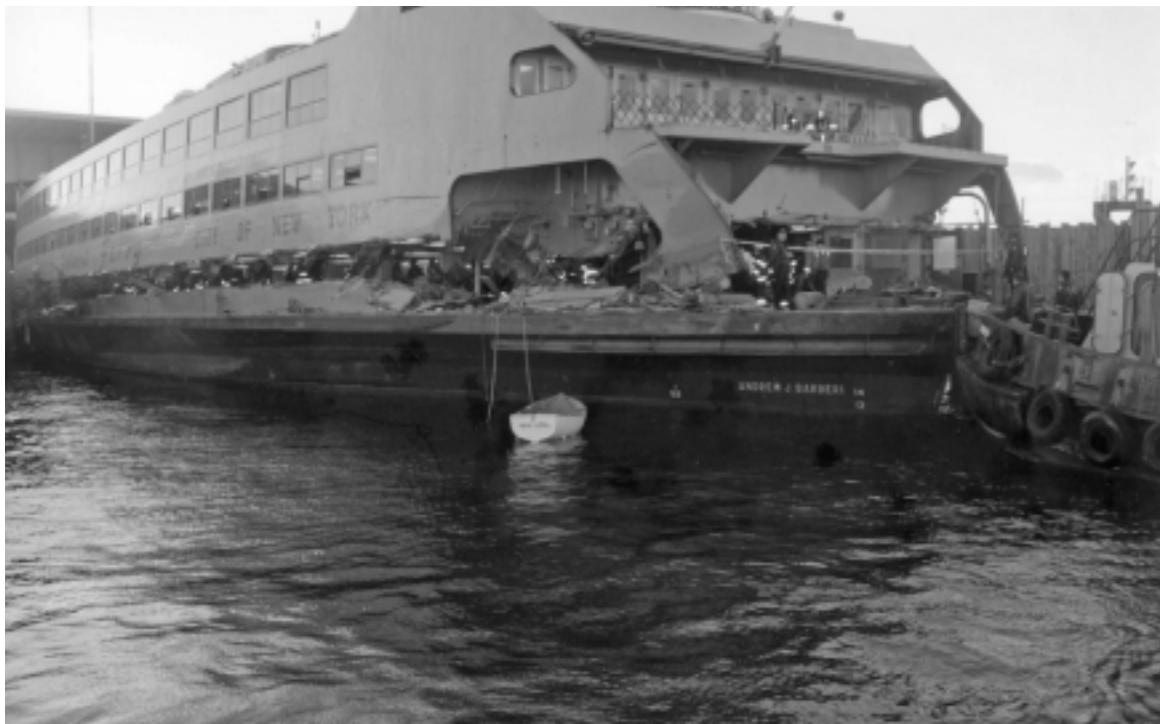
The *Andrew J. Barberi* struck the concrete maintenance pier at an oblique angle and continued to move forward, allowing the concrete to tear a 210-foot-long gash into the main deck on the vessel's New Jersey side (figure 3). The vessel was repaired by a Staten Island company at the Brooklyn Navy Yard at a cost of \$6.9 million. The ferry returned to service in July 2004.

**Figure 3.** Postaccident view of *Andrew J. Barberi*.

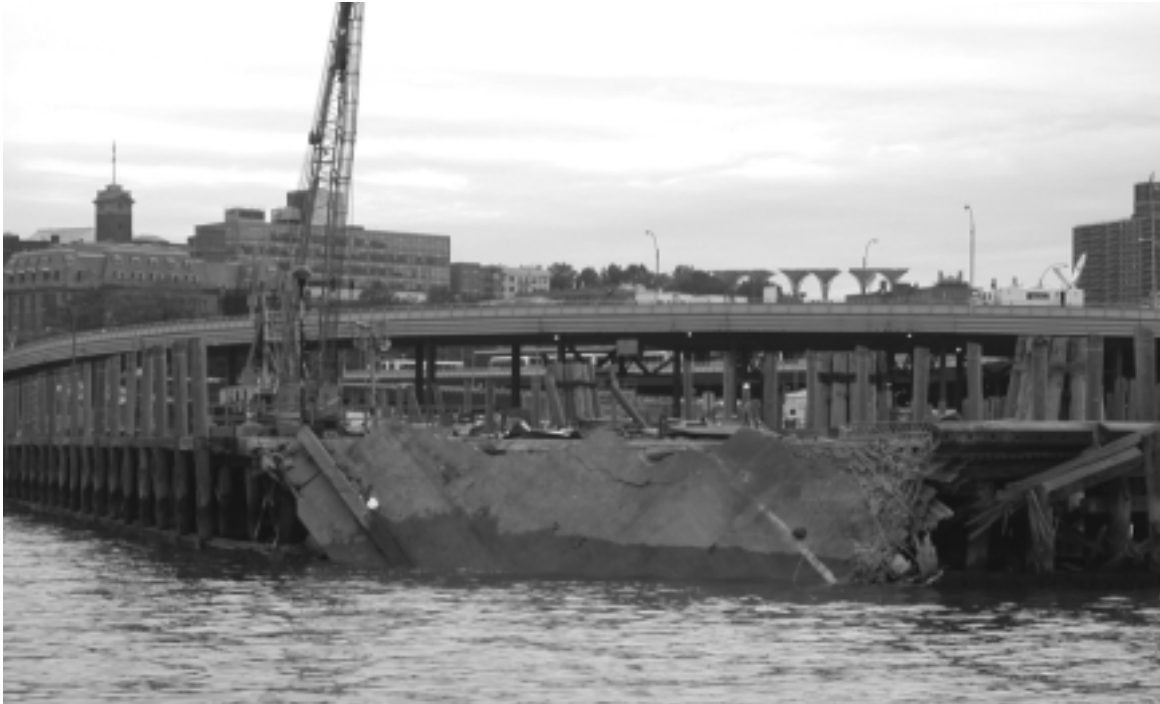
Approximately 1,500 square feet of the surface of pier B-1 collapsed into the harbor after the *Andrew J. Barberi* struck its southeast corner (figure 4). The pier was repaired at a cost of \$1.4 million.

Figure 4. View of damage to maintenance pier caused by *Andrew J. Barberi*.

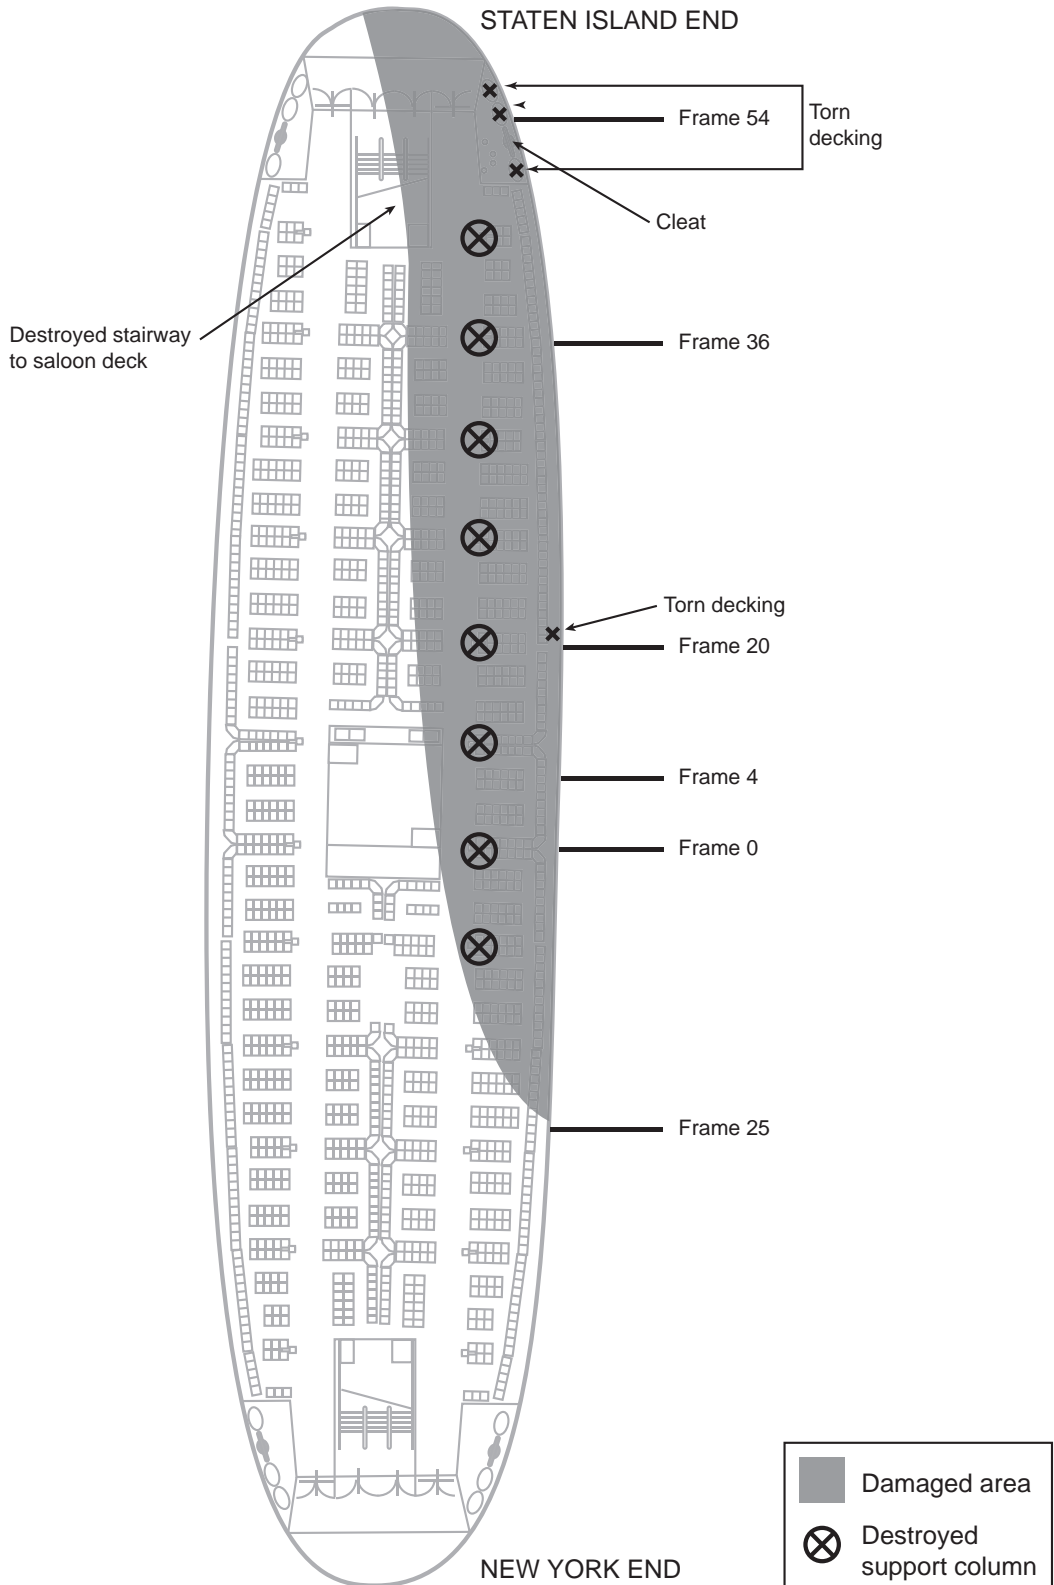
After the accident, the ferry's propulsion system was found undamaged. The vessel's main deck sustained the bulk of the damage, with some tearing of the deck into various voids, machinery, and ballast tank spaces below (figure 8). The leading edge of the starboard passenger cabin on the main deck (Staten Island end), at frame 54, appeared to have taken the brunt of the collision. The bulkhead at frame 54 was fully torn from the deck, from the starboard deck edge inboard through to a point about 12 feet to the left of the centerline.

The deck around the cleat on the starboard side (forward of the cabin) was found largely intact but with a 15-inch longitudinal and 8- to 10-inch transverse tear that created an opening to the ballast tank space below. Four tears that exposed the propulsion room below the main deck were also found. The first, of approximately the same dimensions as the forward tear, was found aft of the cleat. The second, about 4 feet aft of the cleat in the area of the bunker (fuel) station, was associated with numerous flattened and bent pipes leading to the propulsion room (lubrication oil fill connections, fire main connections, fuel oil fill pipes, water tank fill pipes, and tank vents). The third tear was 12 feet inboard of the bulkhead, where a ventilator trunk had been ripped out. The fourth tear was aft of the vent trunk, where a pipe duct had been torn off.

Vertical steel support columns for the frame member that supported the forward superstructure were sheared off on the Staten Island end aft of frame 54 to frame 4. The outboard attachment point of the column at frame 20 was sheared off, but the inboard attachment point was intact. The saloon deck sagged 2 to 3 inches near the forward starboard corner of the pilothouse because of the damage to the supports. The side shell was peeled back from frame 54 at the Staten Island end to frame 25 at the New York end. Bulkheads, seating areas, bulkhead trim, ceiling panels, lighting cables, fixtures, and plumbing systems were destroyed from the bow to about frame 20, inboard of a point about 12 feet left of the centerline.

Figure 8. Plan view of ferry's main deck highlighting damaged areas.

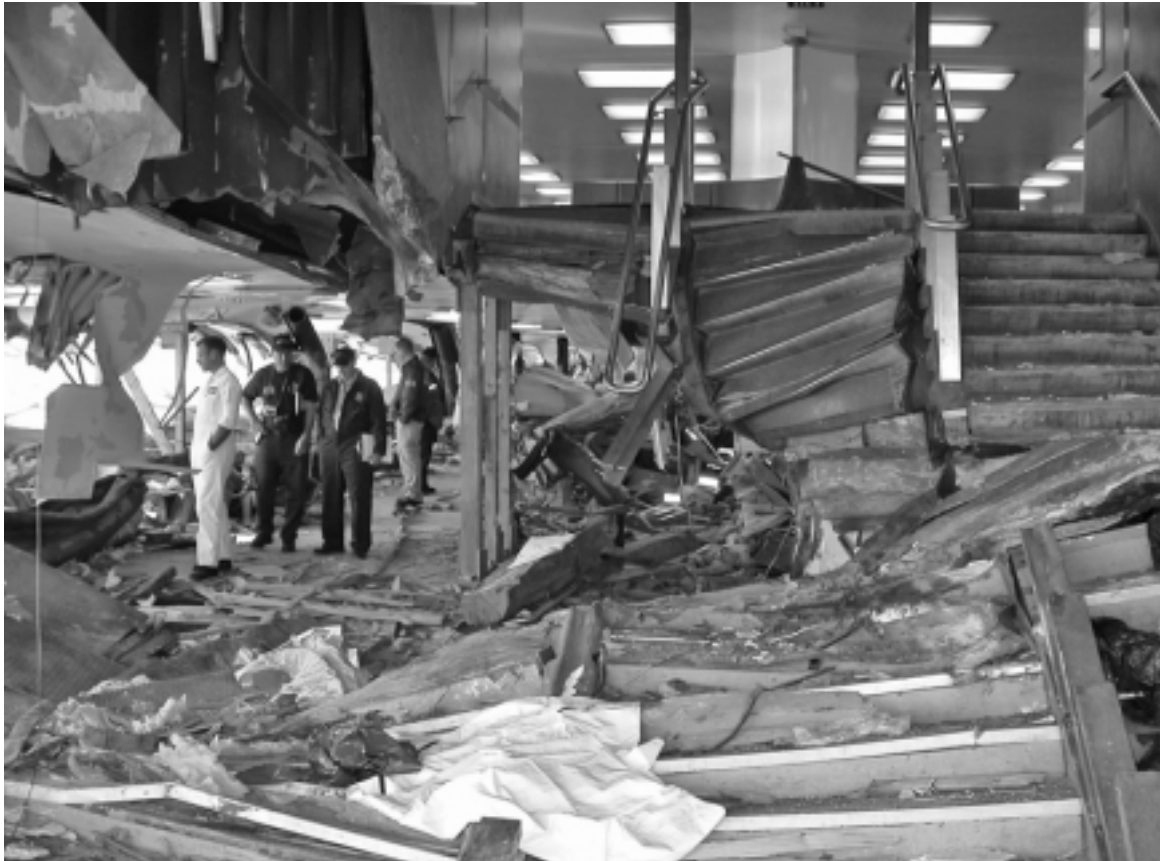
All bulkheads and associated frames, structural support columns, and saloon deck support frames between frames 54 and 44 on the starboard side were missing. The stairs between the main deck and the saloon deck were fully collapsed (figure 9). The centerline support column at frame 36, the forwardmost support column (that is, closest to the Staten Island end) for the pilothouse remained intact and appeared to have provided the main support for the forward pilothouse after the starboard support columns were destroyed.

Figure 9. View of damage to New Jersey side of main deck showing collapsed stairway to saloon deck, destroyed columns, crushed seats, ruined ceiling panels, dislodged cables and fixtures, debris, and other destruction.

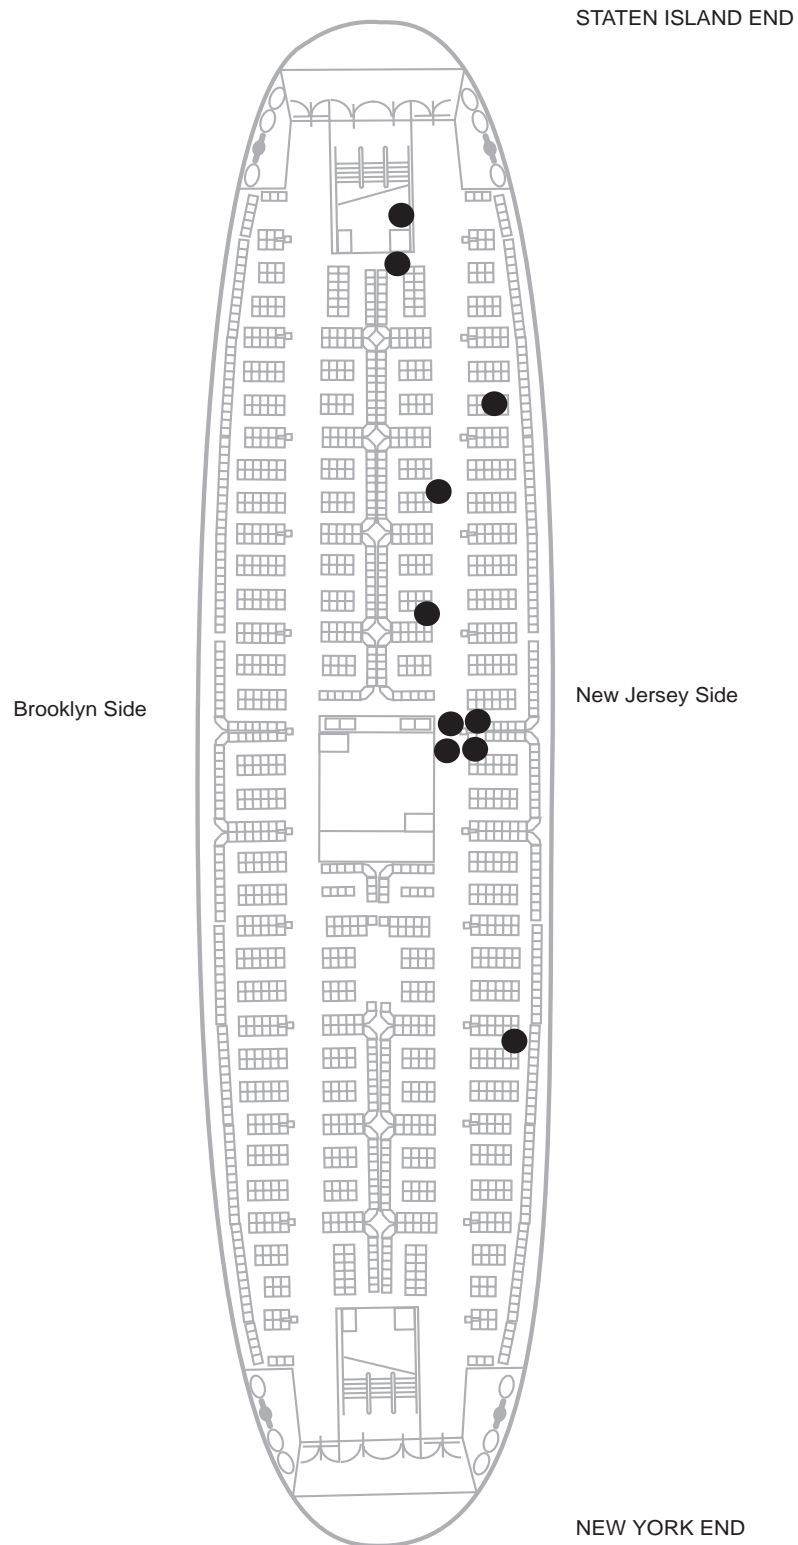
Ten passengers were found dead by emergency response personnel who met the vessel after it docked.⁴² Emergency personnel identified the locations of the fatally injured passengers several days after the accident. All the fatally injured passengers were found on the New Jersey side of the vessel's main deck (figure 10). The cause of death of the fatally injured was blunt force trauma and its consequences, with numerous severe injuries to head, torso, and extremities.

Figure 10. Locations on main deck where emergency personnel recovered bodies of fatally injured passengers. When emergency personnel arrived on board, some bodies had been moved from where fatal injuries occurred.
