MARINE ACCIDENT REPORT

**CAPSIZING AND SINKING OF THE
UNITED STATES DRILLSHIP
GLOMAR JAVA SEA
IN THE SOUTH CHINE SEA
65 NAUTICAL MILES SOUTH-SOUTHWEST
OF HAINAN ISLAND,
PEOPLE'S REPUBLIC OF CHINA
OCTOBER 25, 1983**

**NTSB/MAR-87/02
(SUPERSEDES: NTSB/MAR-84/08)**

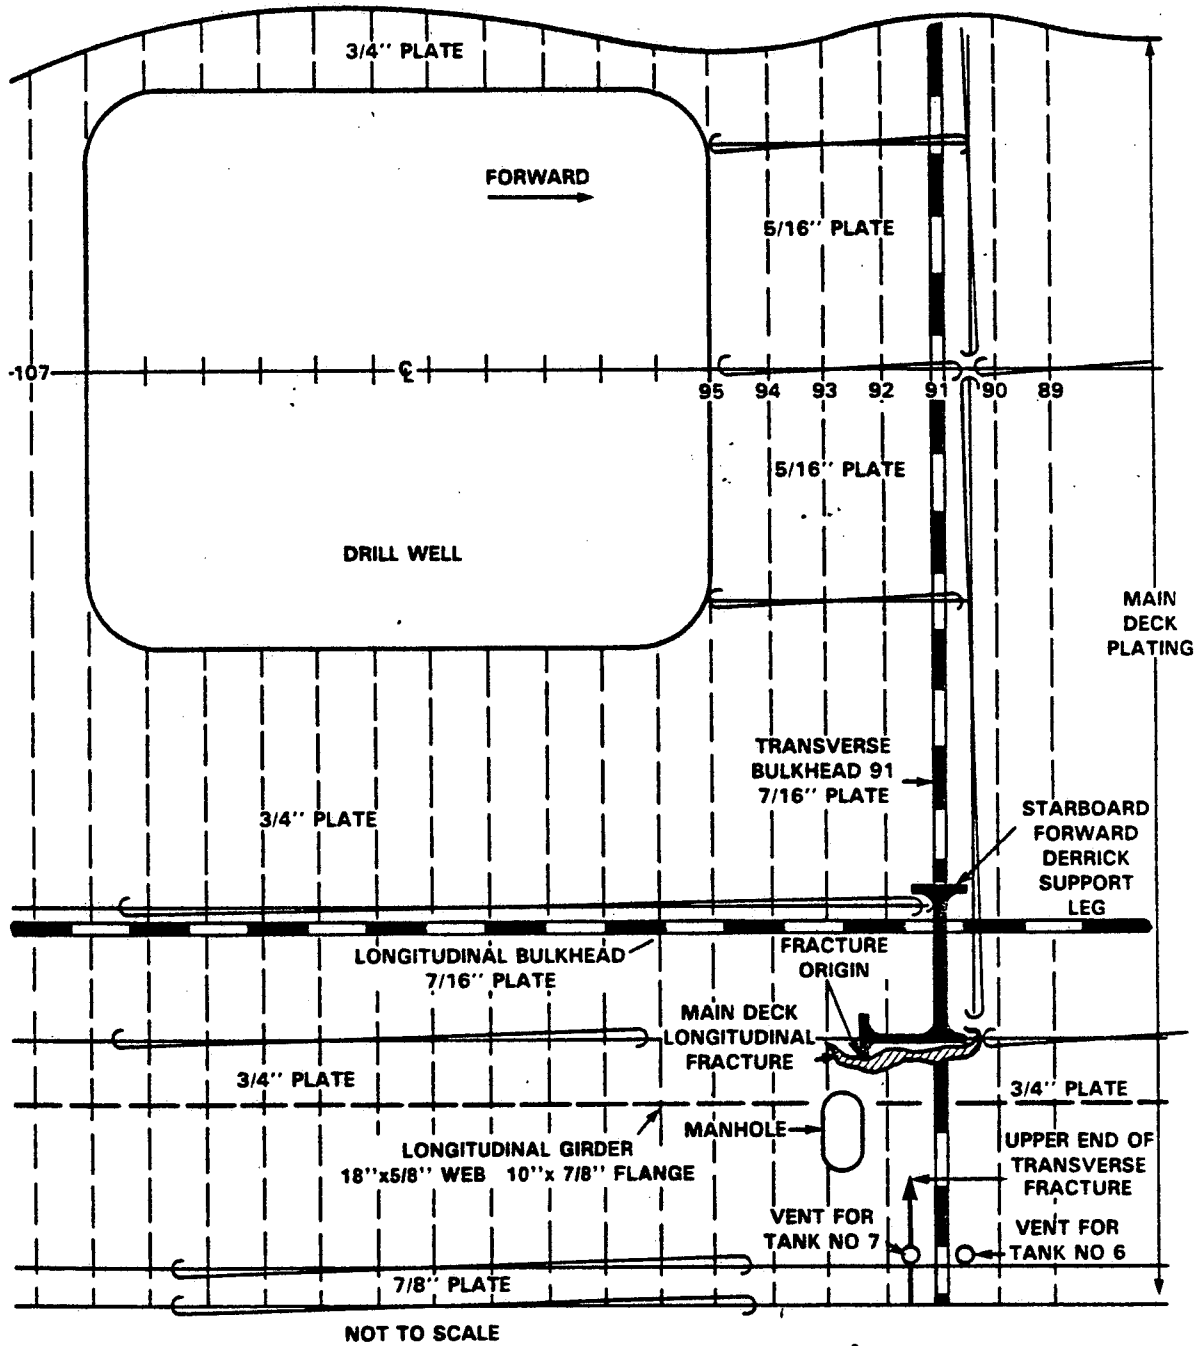
Note: Transverse Frames 89 Through 107 are 6"x3 1/2"x3/8" on 2 Ft Centers

Figure 9.—GLOMAR JAVA SEA main deck plating showing longitudinal fracture and end of transverse fracture.

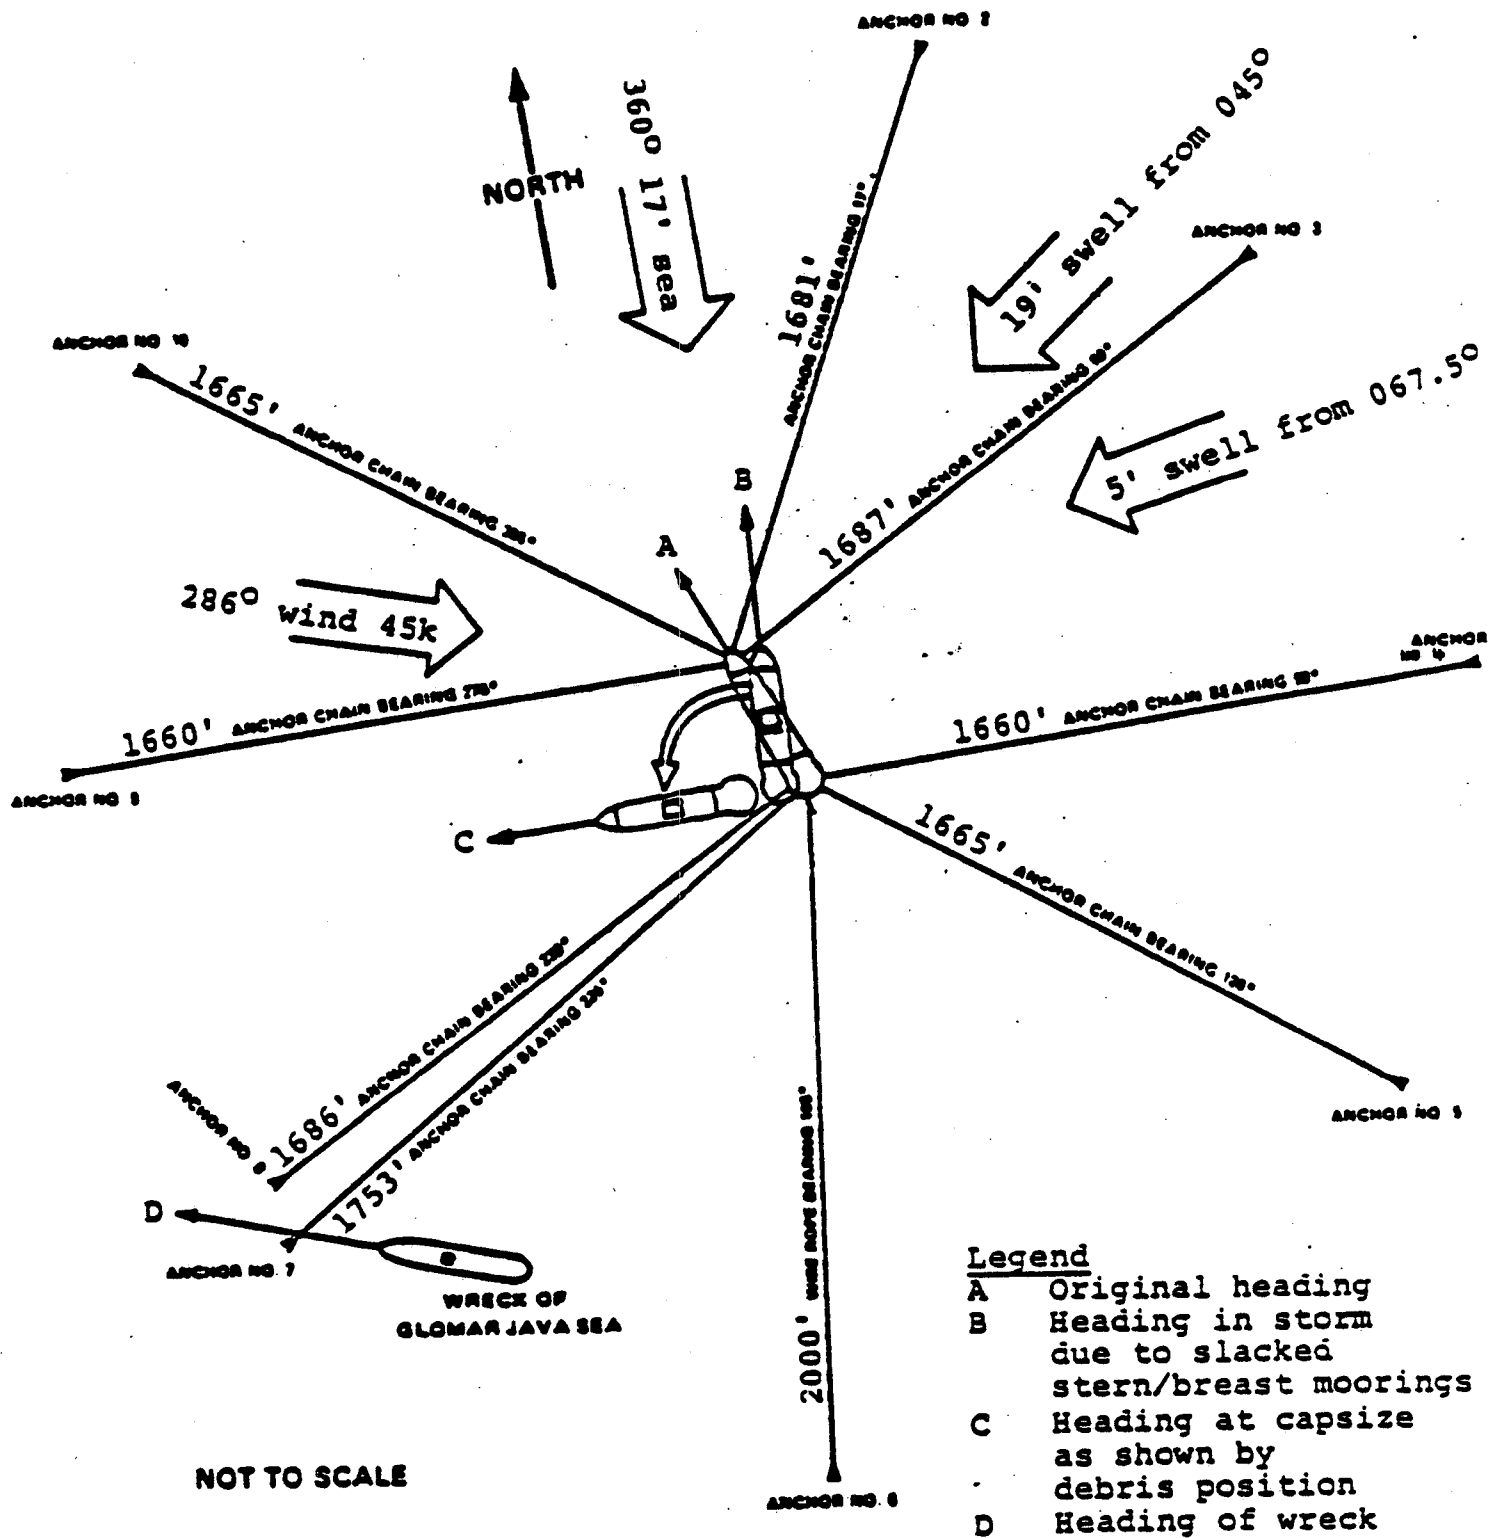
Although evidence gathering and studies are not complete, premature breaking of the starboard bow moorings, triggering a series of events culminating in capsizing and sinking, now appears to be a far more likely explanation for the casualty than the conclusion reached by the Board in its Report.

Figure 1. Headings before and during storm and at capsizing
