Personnel Abandonment of Weather-Damaged
US Liftboat *Trinity II*, with Loss of Life
Bay of Campeche, Gulf of Mexico
September 8, 2011

NTSB/MAR-13/01
PB2013-106633

Marine Accident Report

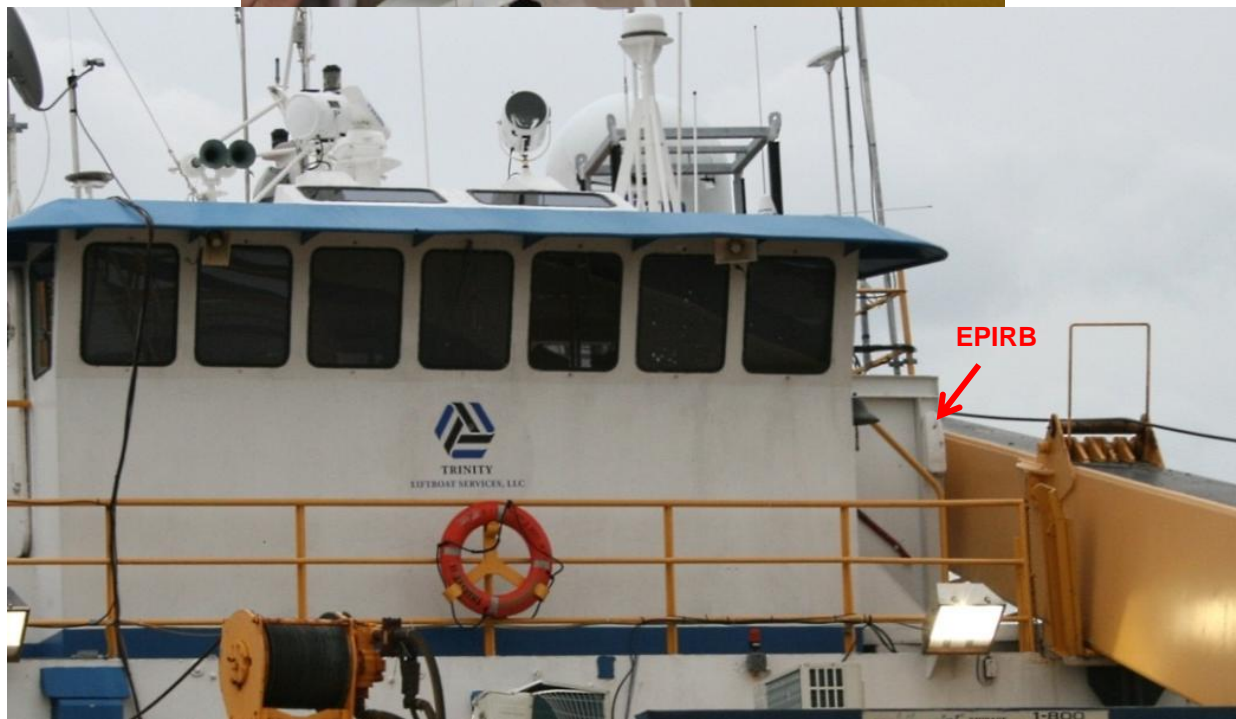
Figure 7. The *Trinity II*'s EPIRB during postaccident examination, and the EPIRB's location on the portside bulkhead just outside the wheelhouse.

The master told investigators that he returned to retrieve the EPIRB, which was located on a port bulkhead immediately outside the wheelhouse (figure 7). The master said that he was unable to retrieve the EPIRB because the portside crane was "picking up and slamming side to side," and he thought that it would hit him if he got too close. The master returned to the main deck without the EPIRB. (After the *Trinity II* was salvaged and returned to port, investigators found the EPIRB still in its container. It was undamaged and had not been activated.)

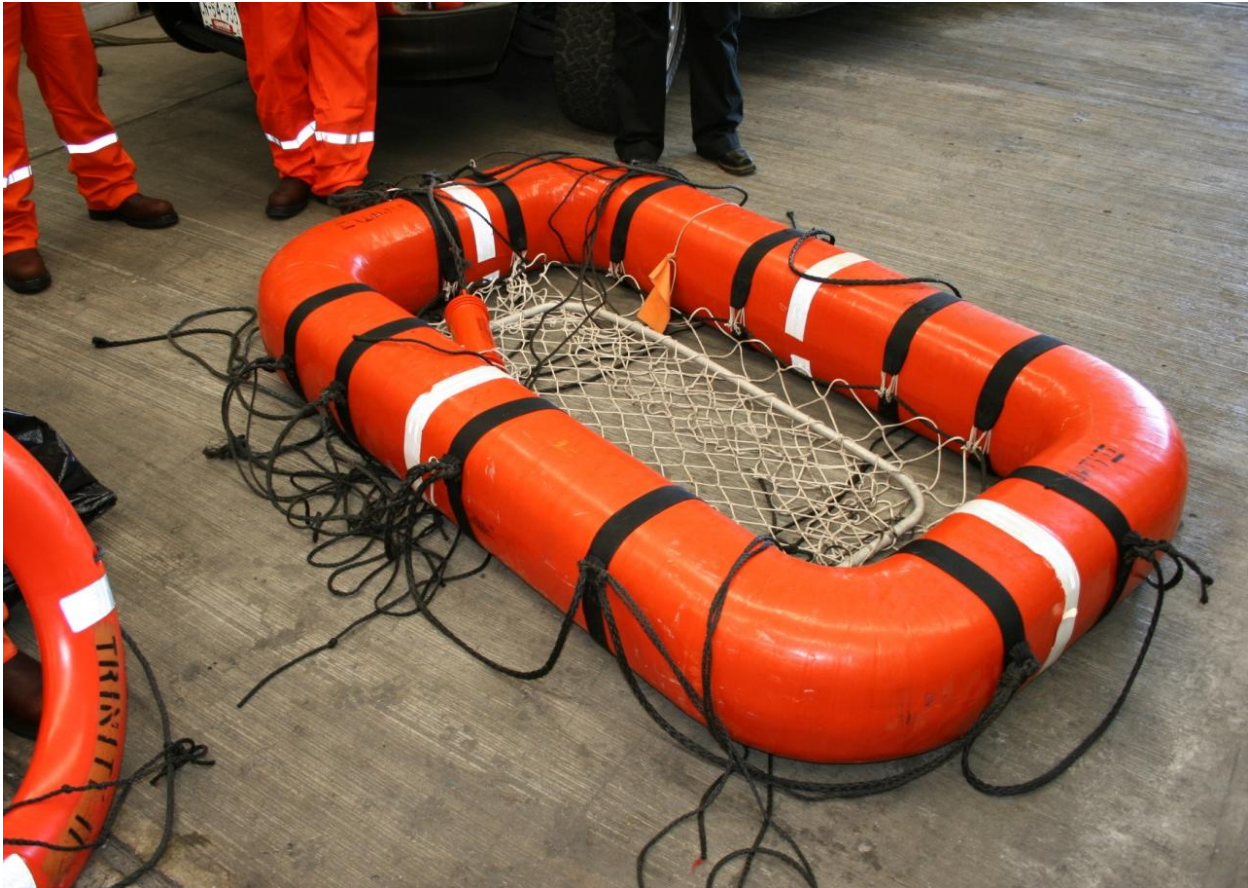
Figure 8. One of the three lifefloats on board the *Trinity II*.

When the master gave the order to abandon ship after the stern leg failed, all persons on board made their way to the main deck. After both of the inflatable liferafts were lost, the cook and another Geokinetics contractor took the initiative to retrieve one of the three lifefloats carried on board. All personnel then abandoned the vessel into the water and held on to the lifefloat grab lines. The fact that all 10 persons were able to remain together for several hours in heavy seas and high winds was a noteworthy accomplishment. However, the failure to take essential supplies with them—such as the EPIRB and the food, water, and emergency flares that the men had prepared before abandoning the vessel—greatly affected their survivability. The master told investigators that he forgot about the EPIRB until he was down on the main deck. He said that he went back to retrieve it but that the crane was moving so much in its cradle that he did not believe he could safely retrieve the EPIRB. After the accident, investigators examined the EPIRB, which they located in its case on the bridge wing, undamaged. The master had not been able to sleep for about 48 hours at the time of the abandonment, and some of the other men were likely sleep-deprived as well. Their aggregate exhaustion and stress level may explain why the safety equipment and supplies were left behind. Therefore, the NTSB concludes that the actions taken by the *Trinity II* crewmembers when abandoning the vessel were of limited effectiveness because the stressed and exhausted crew did not make use of all available safety equipment and supplies, and this reduced the personnel's probability of survival.
