Fire Aboard Construction Barge *Athena 106*  
West Cote Blanche Bay, Louisiana  
October 12, 2006

ACCIDENT REPORT

NTSB/MAR-07/01  
PB2007-916401

# Marine Accident Report

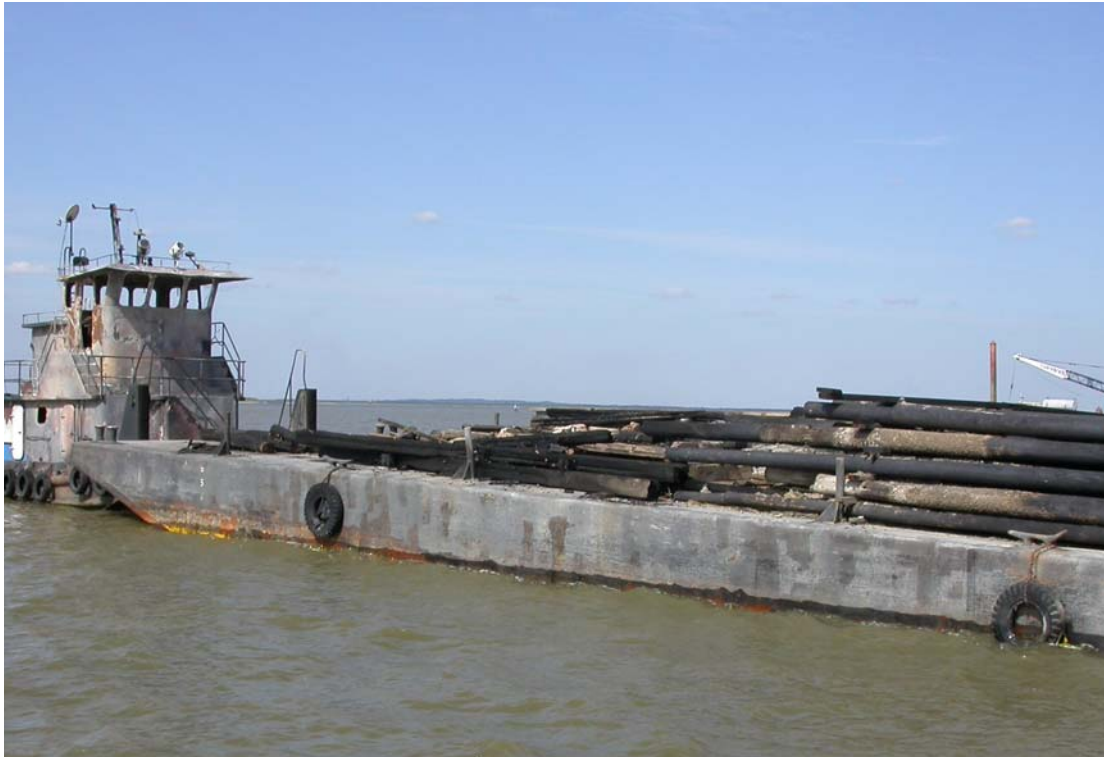
After completing the morning checks, the *Athena 106* crew began extracting pilings. The *IBR 234* was secured alongside the *Athena 106* to store the extracted pilings (figure 4). The barge also housed new pilings that would be driven later.

**Figure 4.** Barge *IBR 234* loaded with pilings (being pushed by the *Miss Megan*).

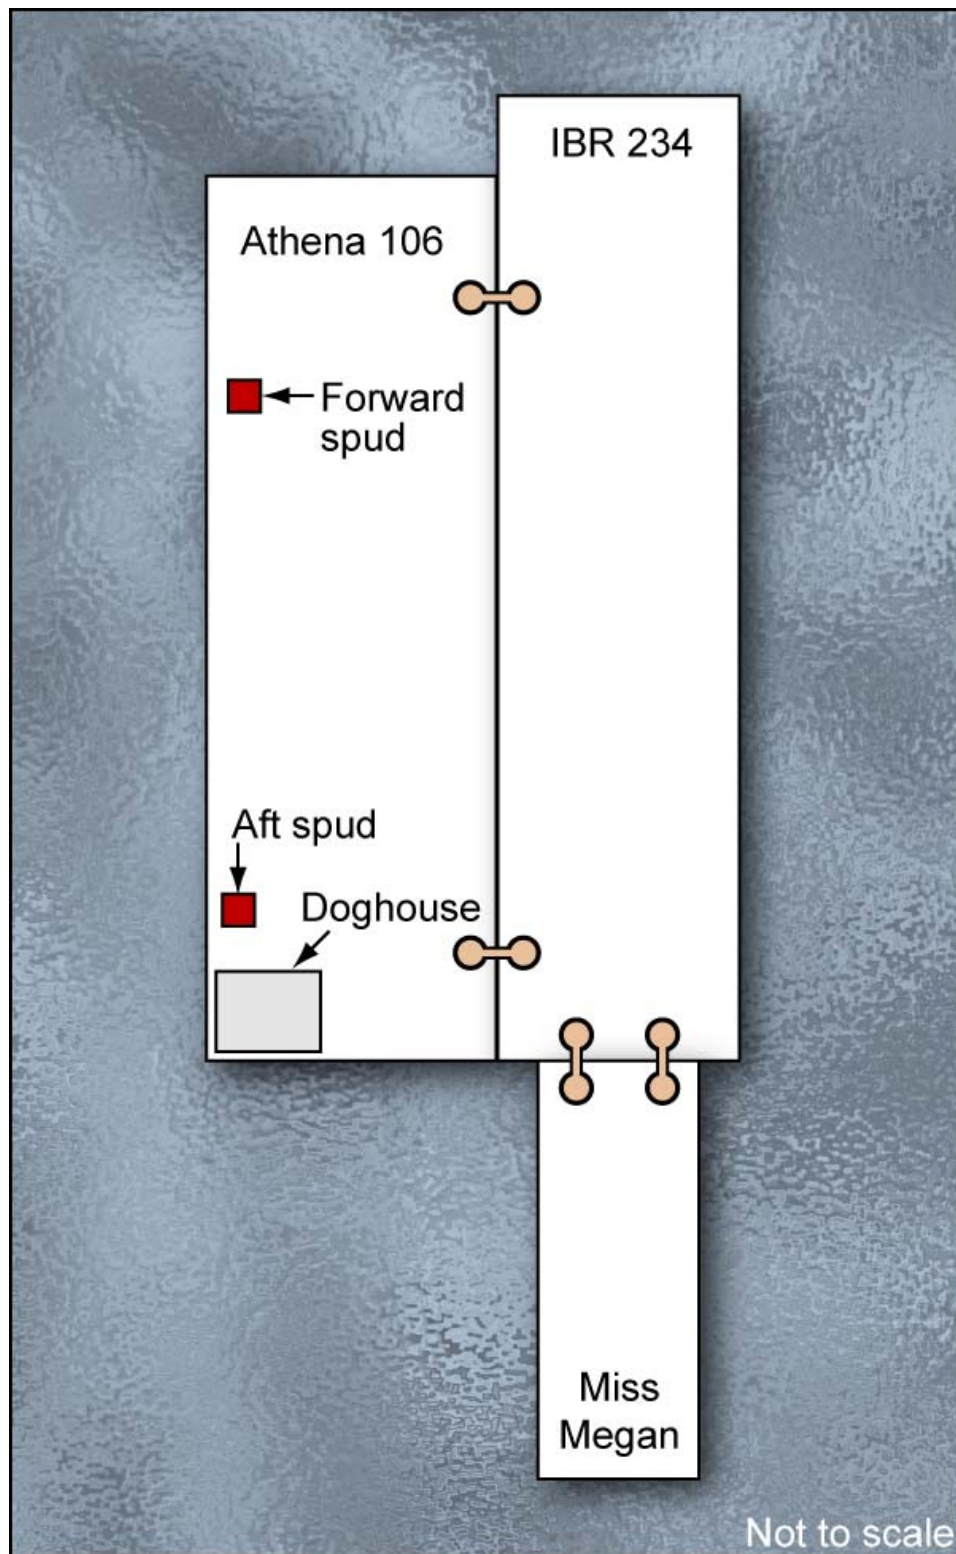
The extraction work continued until about 1130, when the towboat *Miss Megan* arrived and was secured to the aft end of the *IBR 234* in preparation for propelling the two barges to their next work location (figure 5). While the towboat master and deckhand made fast to the barges, the barge crew stopped its work of extracting pilings.

**Figure 5.** Towing arrangement of the *Miss Megan* and the two barges. The barges were tied together, with the *Miss Megan* secured to the aft end of the *IBR 234* and pushing both barges.
