MARINE ACCIDENT REPORT

**CAPSIZING AND SINKING OF THE
UNITED STATES DRILLSHIP
GLOMAR JAVA SEA
IN THE SOUTH CHINE SEA
65 NAUTICAL MILES SOUTH-SOUTHWEST
OF HAINAN ISLAND,
PEOPLE'S REPUBLIC OF CHINA
OCTOBER 25, 1983**

**NTSB/MAR-87/02
(SUPERSEDES: NTSB/MAR-84/08)**

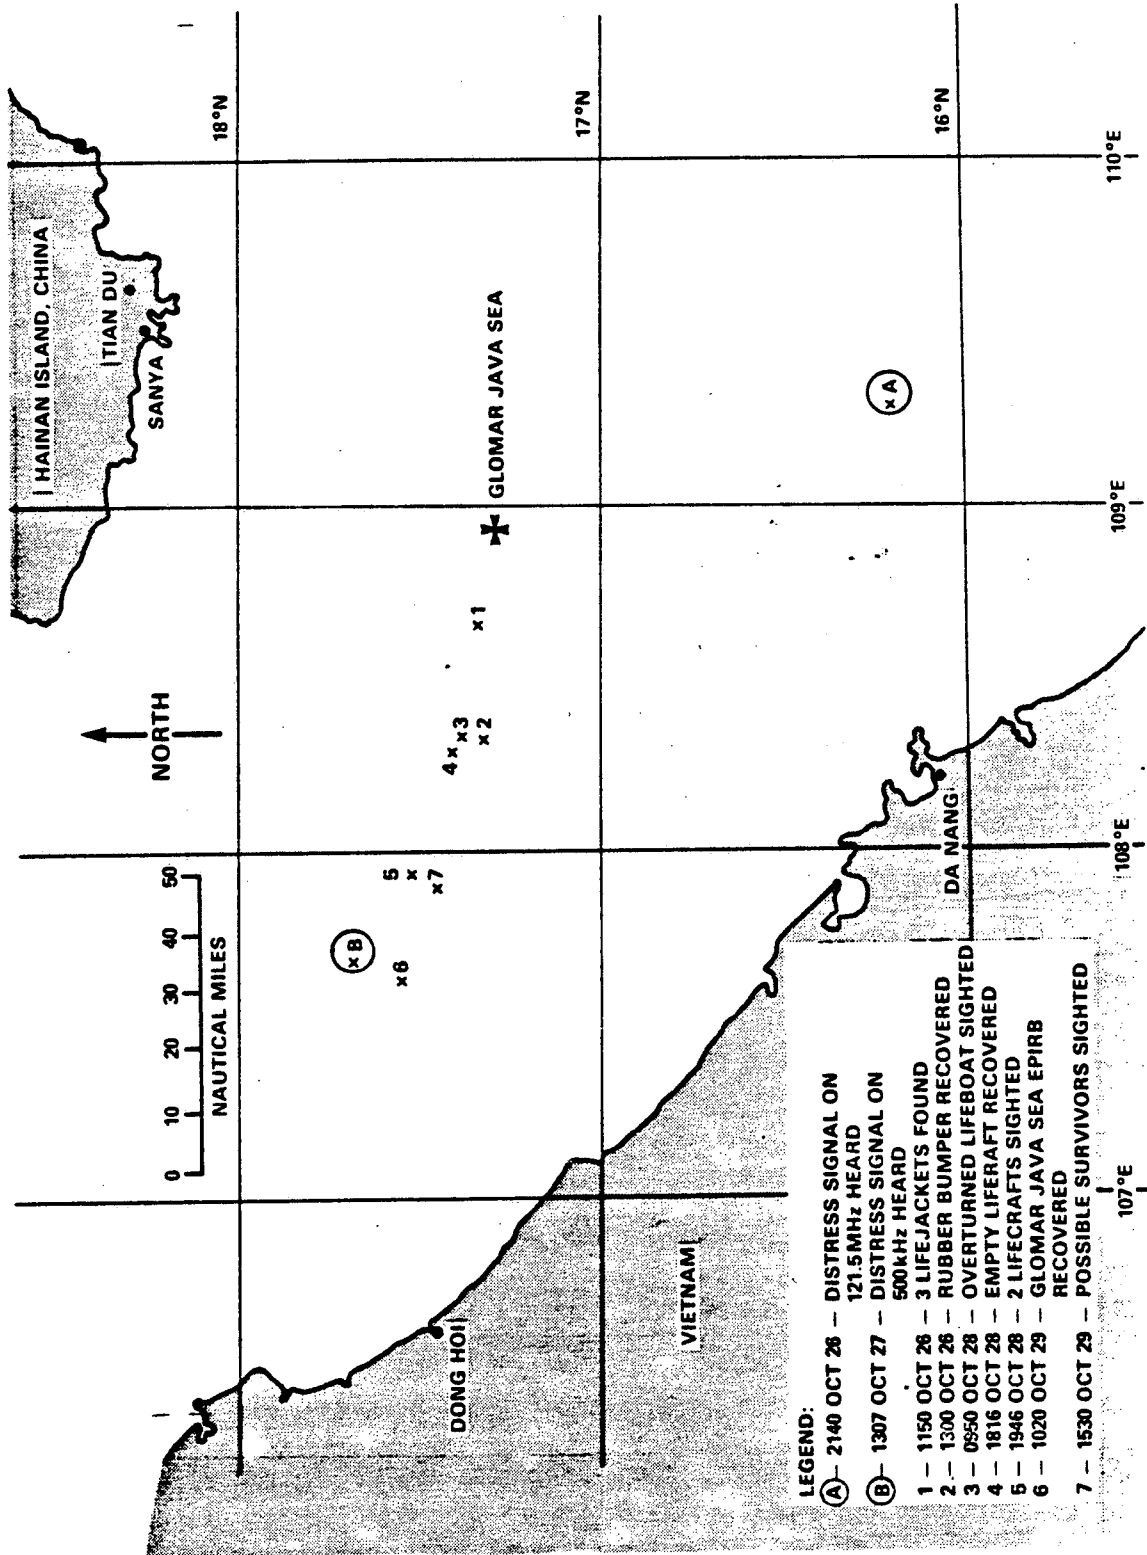
Figure 3.—Search and rescue effort from October 26 to October 29, 1983.

At 0430 on October 27, a commercial airplane reported to the Hong Kong Marine Department that an intermittent distress signal on 121.5 MHz was heard at 2140 on October 26 about 60 to 70 nmi east of Da Nang, Vietnam. This information was passed on to Kadena. It was later determined that a distress signal transmitted from that location could not have come from the GLOMAR JAVA SEA's emergency position indicating radio beacon (EPIRB). At 0643 on October 27, Kadena alerted its search and rescue airplanes and at 0747 launched a P-3 airplane with an estimated time en route of 3 hours. The P-3 spent 6 hours searching the drill site using a 25-nmi track spacing at an altitude of 300 to 400 feet. The area covered was bounded approximately by 14°30' N. latitude on the south, 30 nmi off the Vietnam coast on the east, 18° N. latitude on the north, and 110° E. longitude on the west. Due to the poor weather conditions, most of the unsuccessful search was conducted by radar. During the afternoon of October 27, a Singaporean ship about 200 nmi southeast of Saigon, Vietnam (see figure 2), en route from Dubai, United Arab Emirates, to Kobe, Japan, reported to the Marine Department of Hong Kong that it had received a distress signal on 500 kHz at 1307 on October 27. The distress signal included the GLOMAR JAVA SEA's call signal, WFDS, and a position of 17.41° N., 107.42° E. (about 70 nmi to the northwest of the well location). (See figure 3.) A vessel was sent to locate the source of the signal, but it was not found.

At 1345, Kadena launched a second search airplane which spent 4.7 hours searching the drill site using a 16-nmi track spacing at an altitude of 500 feet. The area to the south and east of the well location was searched with negative results. About 1400, the NANHAI 205 began a fathometer survey of the ocean floor within the drillship's anchor buoys. At 1500, the weather conditions improved at Sanya and the ARCO operating manager flew on a British Petroleum Sikorsky 61 helicopter from Zhanjiang to Sanya. The NANHAI 209 with the other members of the search team arrived in Sanya about 1600, and the ARCO assistant manager arrived at 1700. About the same time, the NANHAI 205's fathometer survey had located a wreck about the size of the GLOMAR JAVA SEA about 1,400 feet to the southwest of the well location but within the buoy pattern. It was later determined that the wreck was actually 1,650 feet to the southwest. (See figure 4.) At 2023, Kadena was informed of the distress message on 500 kHz from a position northwest of the well location.
